**REPORT OF INVESTIGATION INTO THE CIRCUMSTANCES
SURROUNDING THE GROUNDING OF THE**

MONARCH OF THE SEAS

**ON PROSELYTE REEF IN GREAT BAY, PHILIPSBURG,
ST. MAARTEN, NETHERLANDS ANTILLES ON**

DECEMBER 15, 1998

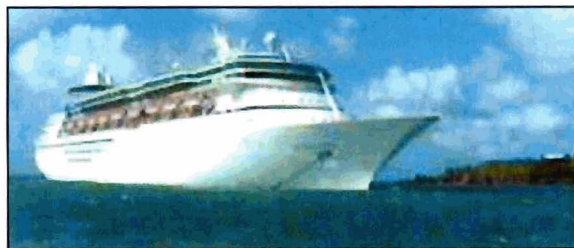
MONARCH aground in Philipsburg harbor.

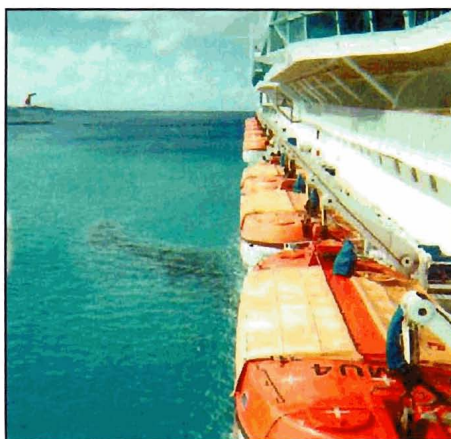
View of lifeboats from the starboard
bridge wing looking aft. Note oil spill.

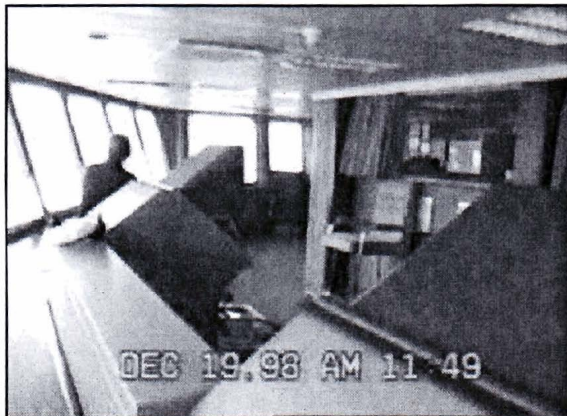
MONARCH's bridge, view from centerline forward to starboard. Hooded equipment on middle-left of photo is the ARPA in use by the OOW at the time of casualty.

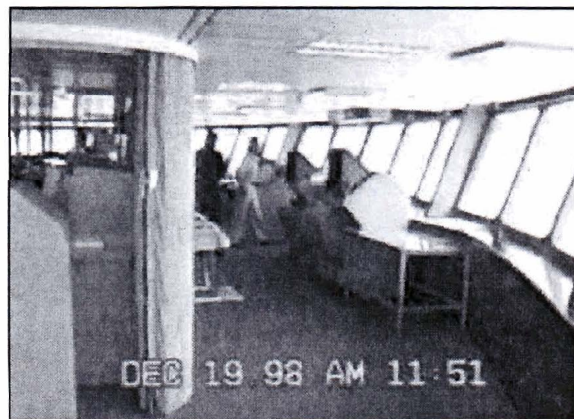
Starboard side of bridge looking toward steering station and starboard ARPA.

to input, either manually or automatically, set/drift calculations into the ARPA nor did he ground lock the ARPA.

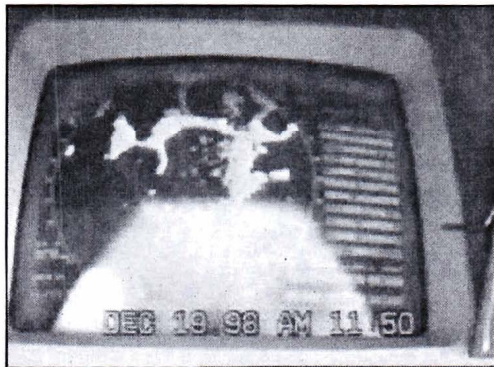
ARPA display showing Great Bay

Almost immediately after hanging up the telephone with the pursers' desk the OOW observed the Proselyte Reef lighted buoy abeam to starboard both visually and on the radar. He also observed on the ARPA that the ship was three cable lengths off (0.3 nm) the buoy. At that moment he ordered the helmsman to change the course to starboard and to steady up on a true course of 190 degrees. No visual bearings were taken nor were any other navigational instruments used. The only instrument used to determine the ship's position in relation to the aforementioned lighted-buoy was the ARPA.

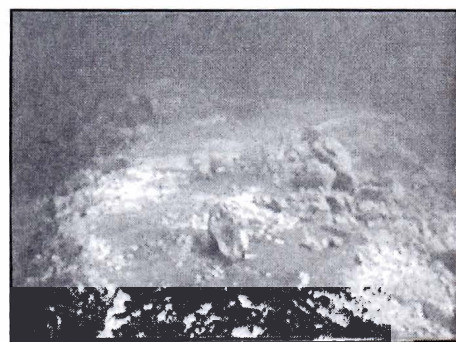
At about 0130 hours, at the point where the ship had started turning to starboard and had reached a course of approximately 163-164 degrees, the *MONARCH OF THE SEAS* raked the Proselyte Reef at an approximate speed of 12 knots without becoming permanently stranded.

Reef Damage

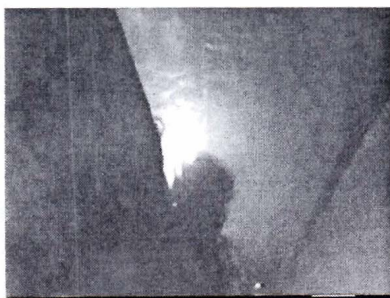
Diver surveying a crack in bottom shell plate

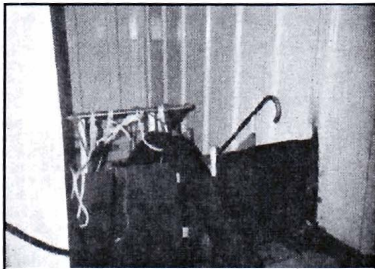
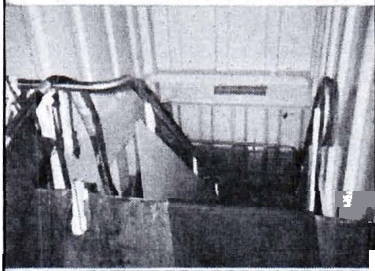
Resultant flooding of stairwell on main deck, port side, forward passageway. Note the welded steel plate across opening to prevent further progressive flooding.

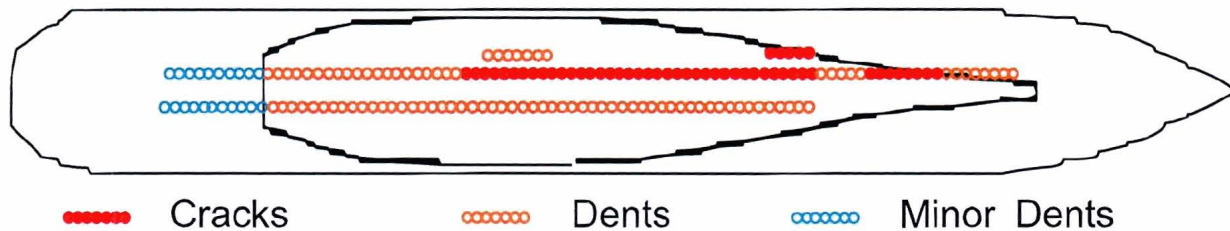
Approximate Limits of Damage to the Ship's Bottom

Summary of damage to the ship's bottom:

Double Bottom Damage	Inner Hull Damage
9 ballast tanks	Laundry area
5 voids	Photo labs
2 fuel tanks	2 pump rooms

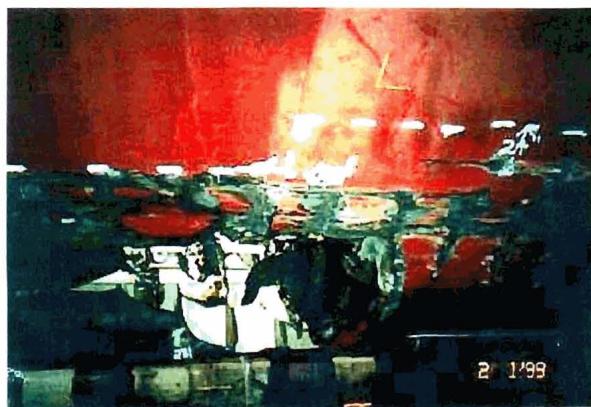
Damage to the bottom, port side.

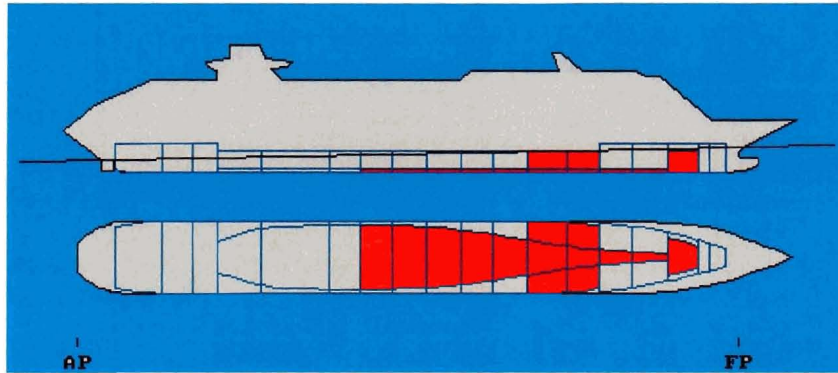
Flooded Areas of the Vessel

- The Coast Guard's stability analysis concluded that *MONARCH OF THE SEAS* would have stayed afloat in open water **provided** that there was no progressive flooding due to additional structural failures such as watertight subdivision boundaries.
- The vessel would have remained afloat at least 12 hours during which the vessel would have remained stable enough to launch its lifeboats and liferafts.
- The presence of double bottoms greatly contributed to the vessel's ability to survive.
- SOLAS damage requirements ensured adequate reserve buoyancy.

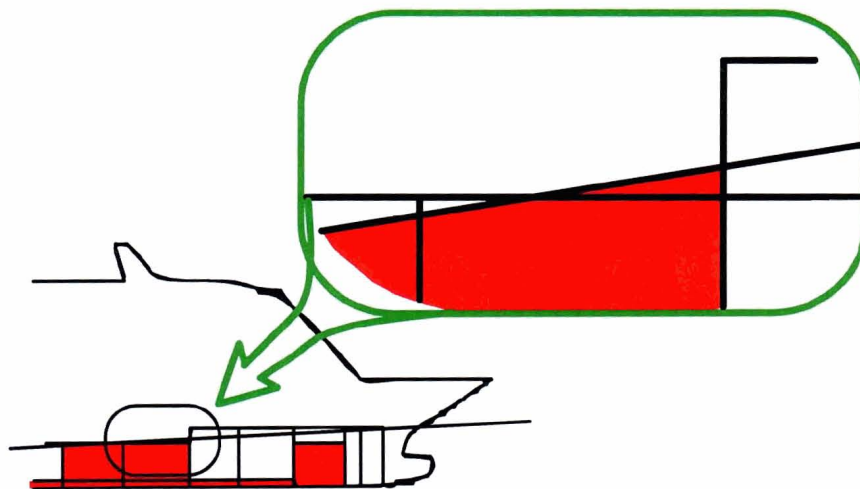
Note: The "stepped bulkheads" forward of pump room no. 1 were a primary reason why the ship stayed afloat.

Diagram indicating the stepped bulkheads.

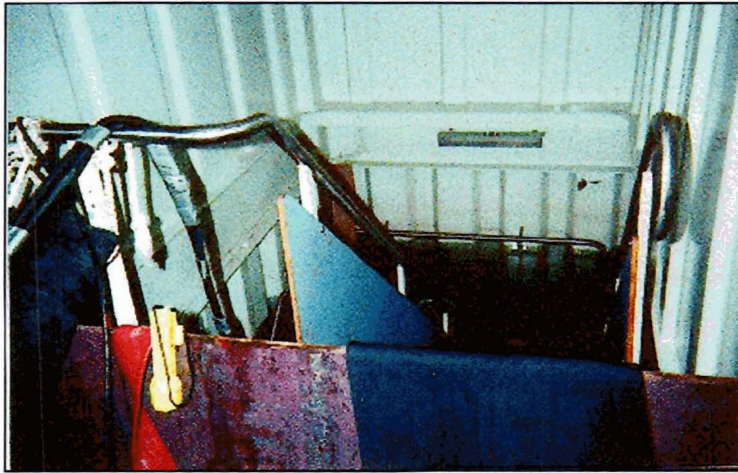
Deck 1, port side passageway. Note welded plate across stairwell put in place to limit the chance of progressive flooding.

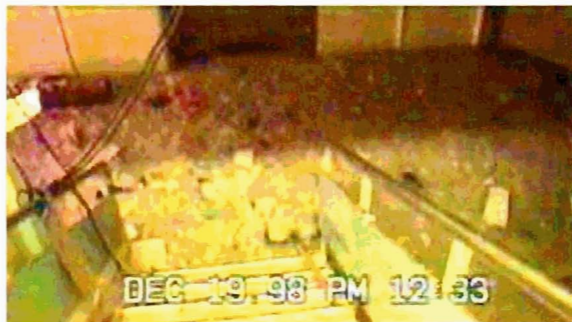
Flooded storage room with paper waste slurry.

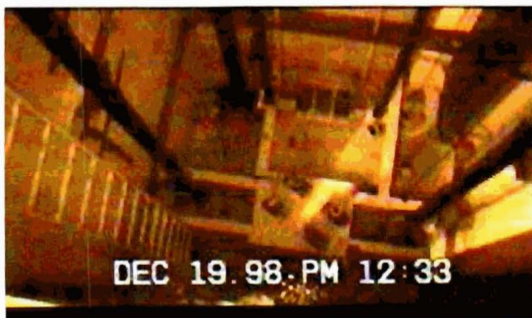
Top down view of a flooded elevator shaft and top of elevator.

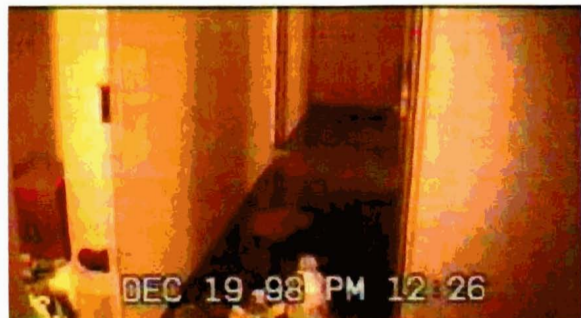
Flooding of crew staterooms.

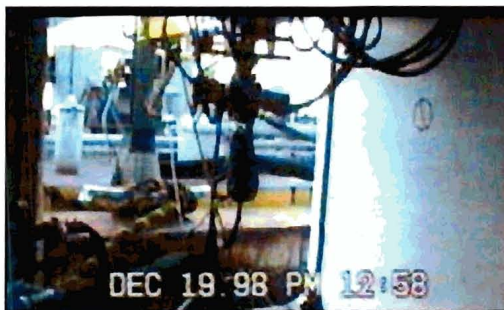
View from just inside side shell port used in the evacuation of the vessel. Note overhead obstructions

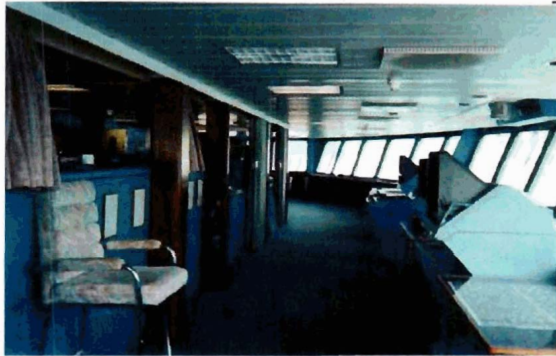
Starboard side of bridge looking toward centerline. ARPA used by OOW is to the right in photo.

The OOW's decision to use the ARPA to plot Proselyte Reef lighted buoy as the sole navigational instrument and reference point was contrary to the rules of good seamanship, his training as a navigational officer and the vessel's established standard operating procedure. This routine violation can be attributed to a human tendency to take the path of least resistance and accomplish the easiest job function deemed appropriate at the time in order to get the job done.

The ARPA unit was located on the forward, starboard side of the bridge, which provides a navigator the optimal location to view radar information as well as any vessel traffic on the starboard or burdened side of the vessel. Further, the ARPA display provides the navigator with a myriad of critical radar information. For these reasons it is reasonable that a watch officer would take up station near or at the starboard ARPA. However, the layout of navigational equipment on the bridge failed to allow easy access to the chart table or the output information of other electronic navigational instruments such as the GPS receiver and thus would serve to hamper a navigator's efforts to verify and plot the vessels position by other navigational means. All navigational charts and navigational instruments were located to the rear of the bridge and required a navigational watch officer to physically step around the vast chart table and move to the aft end or rear of the bridge away from the ARPA; a valuable and easy to use navigation aid.

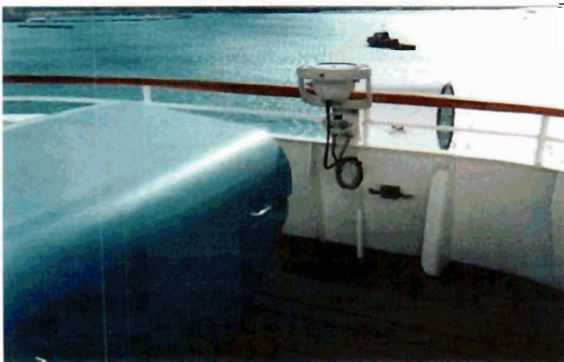
Starboard bridgewing gyro repeater. Note the obstruction in the left foreground.
